BUREAU OF SHIPS GROUP TECHNICAL INSPECTION REPORT

OPERATION CROSSROADS. U.S.S. INDEPENDENCE (CVL22)

TEST ABLE

VOLUME 1 OF 4 [U].

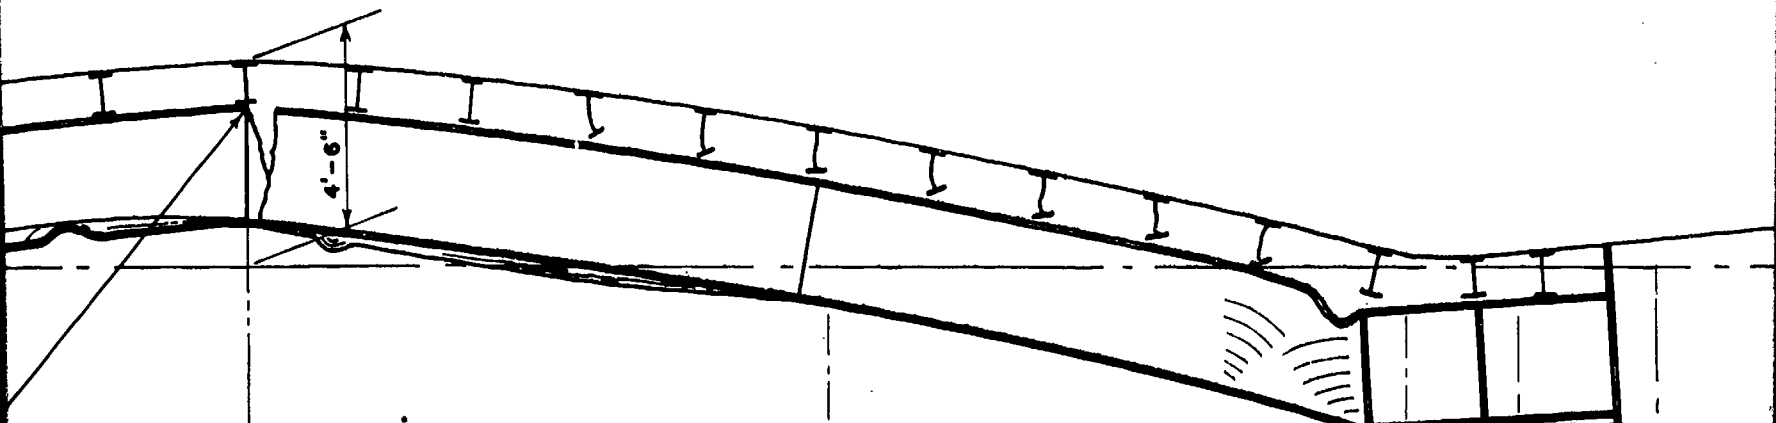
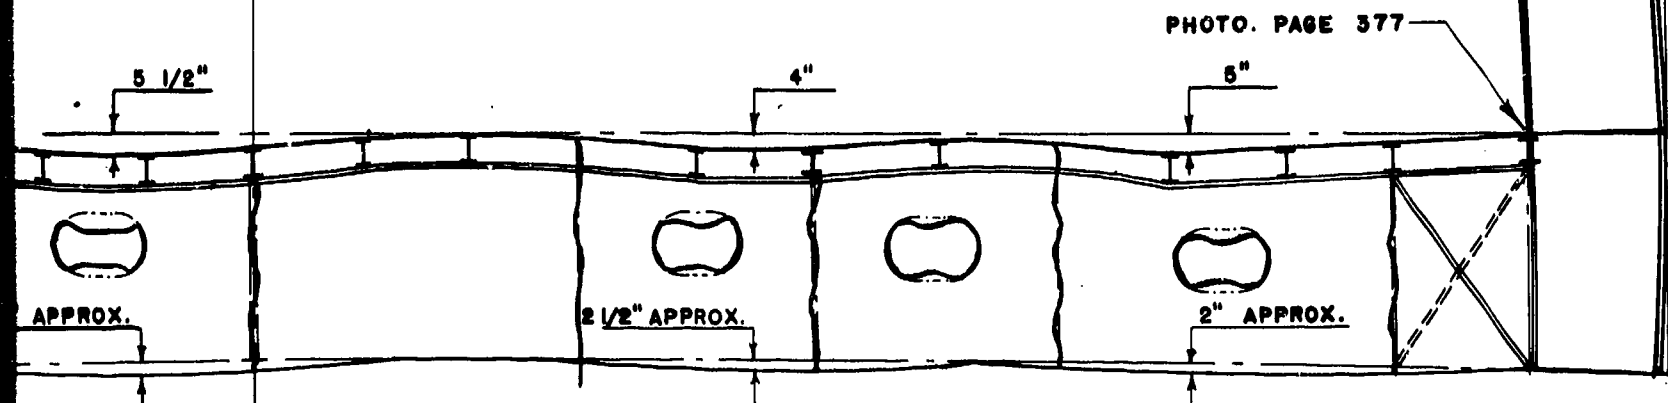
VERSE SECTION AT FR.77
LOOKING AFT.

RACTURE ORIGINATED AT EDGE OF WELD
TOP FLANGE OF GIRDER.

OTOS.- VOL. 3, PAGES 379 - 382

SLIGHT FRACTURE WITH ORIGIN AT UPPER
EDGE OF WELD JOINING COLUMN AND
BRACKET FLANGE.

PHOTOS.- VOL. 3 PAGE 378

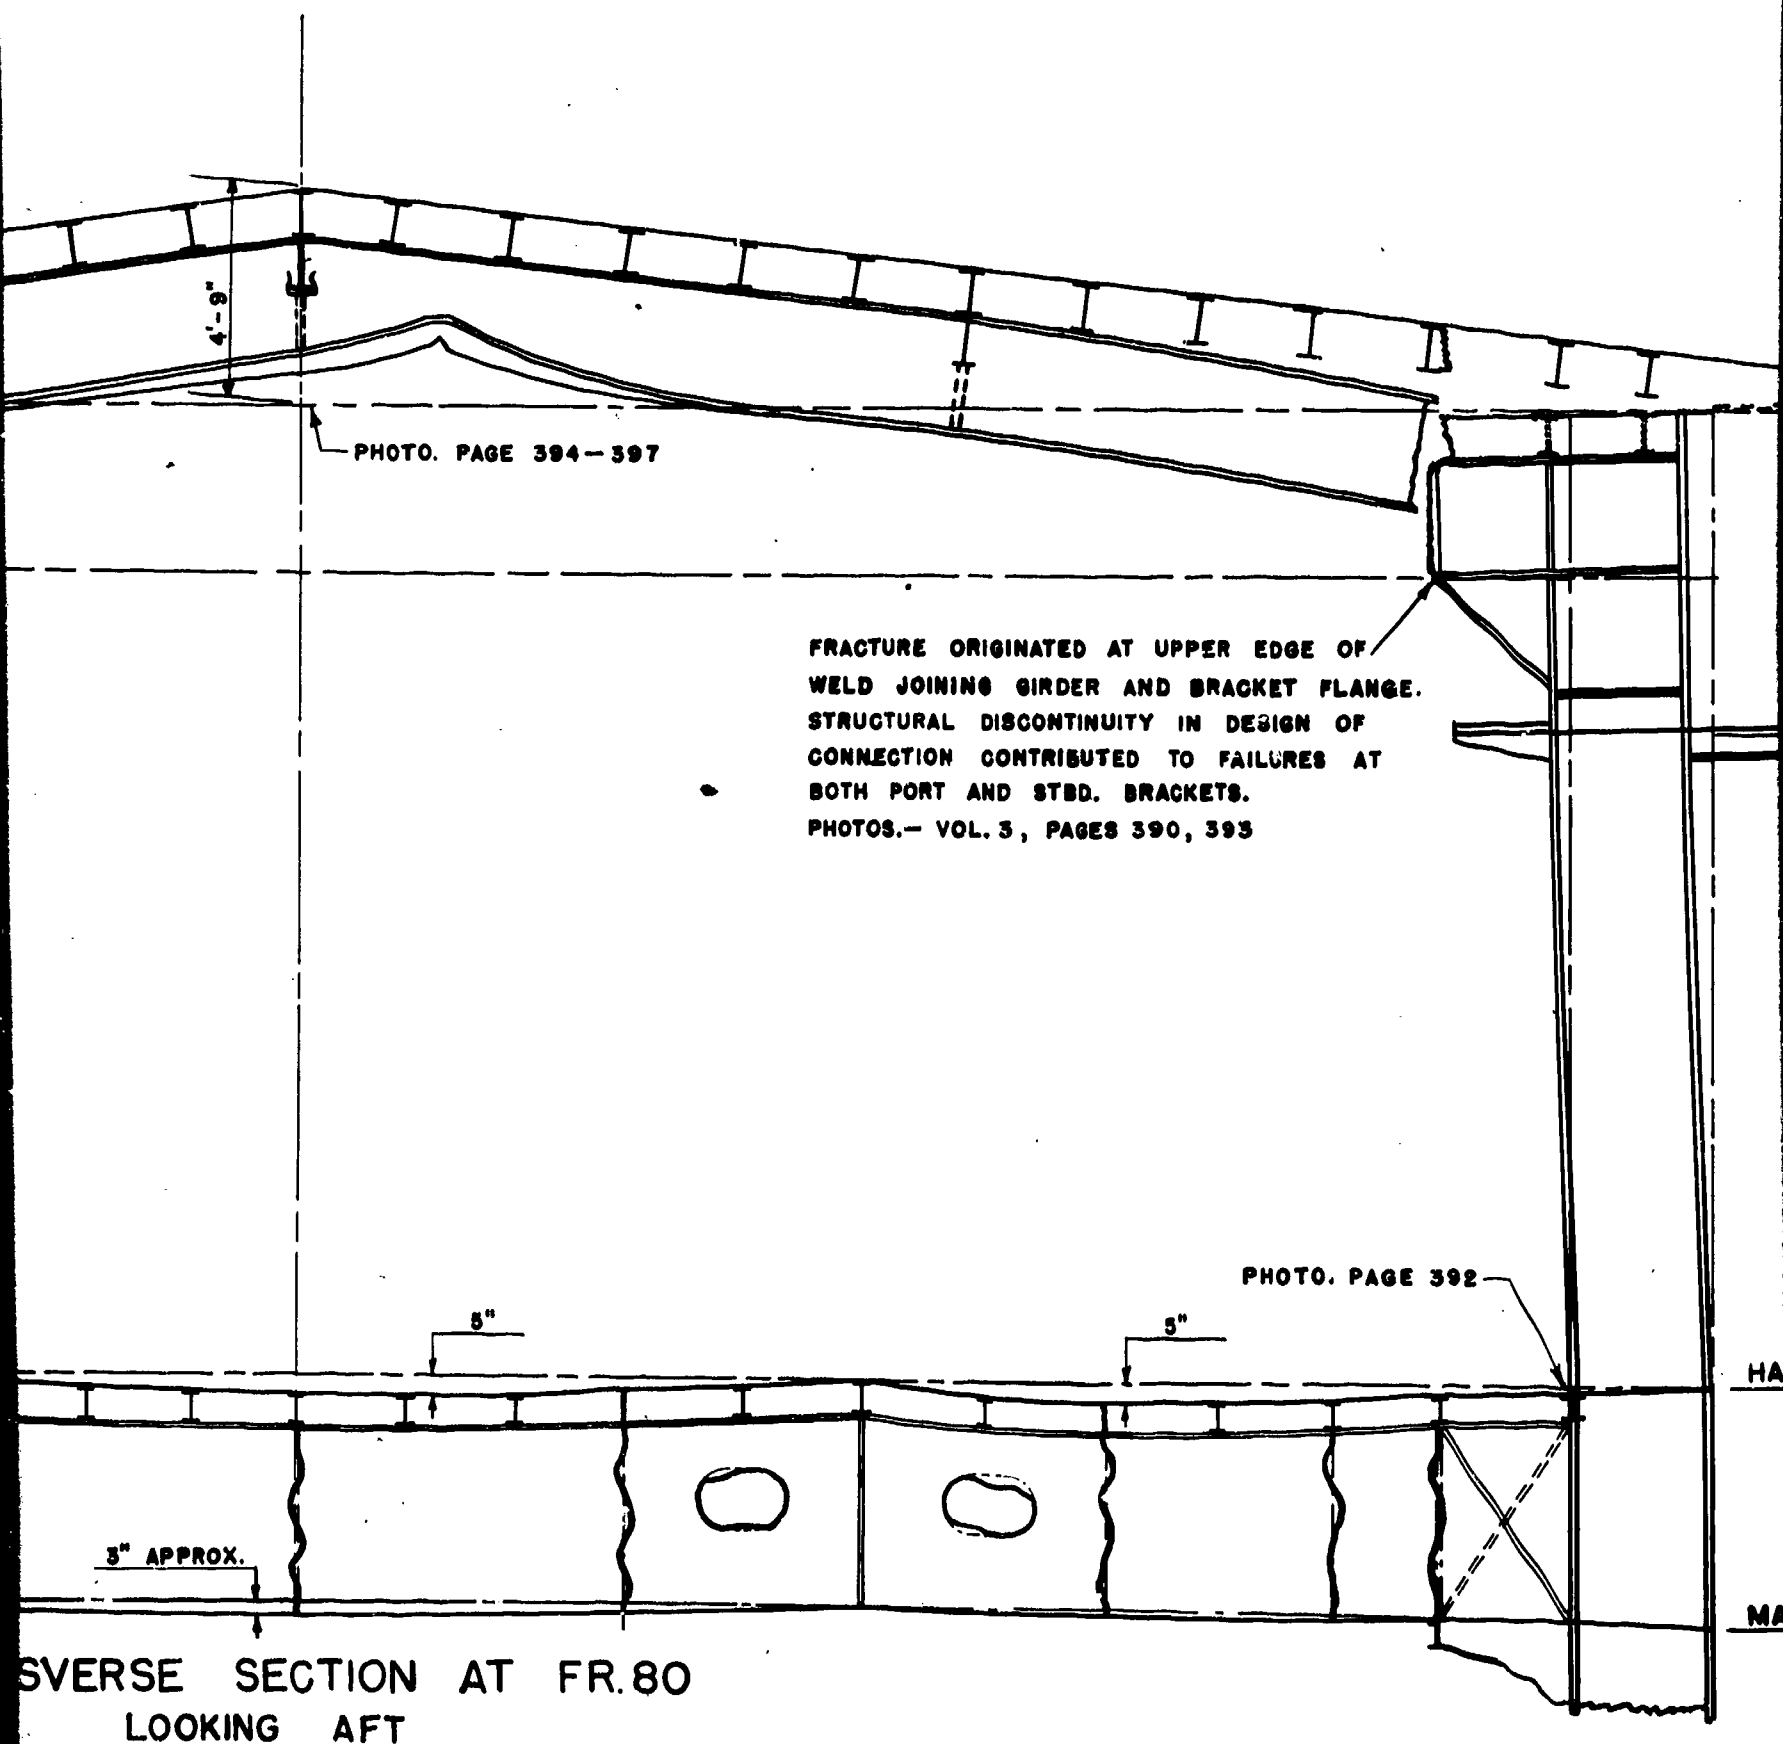
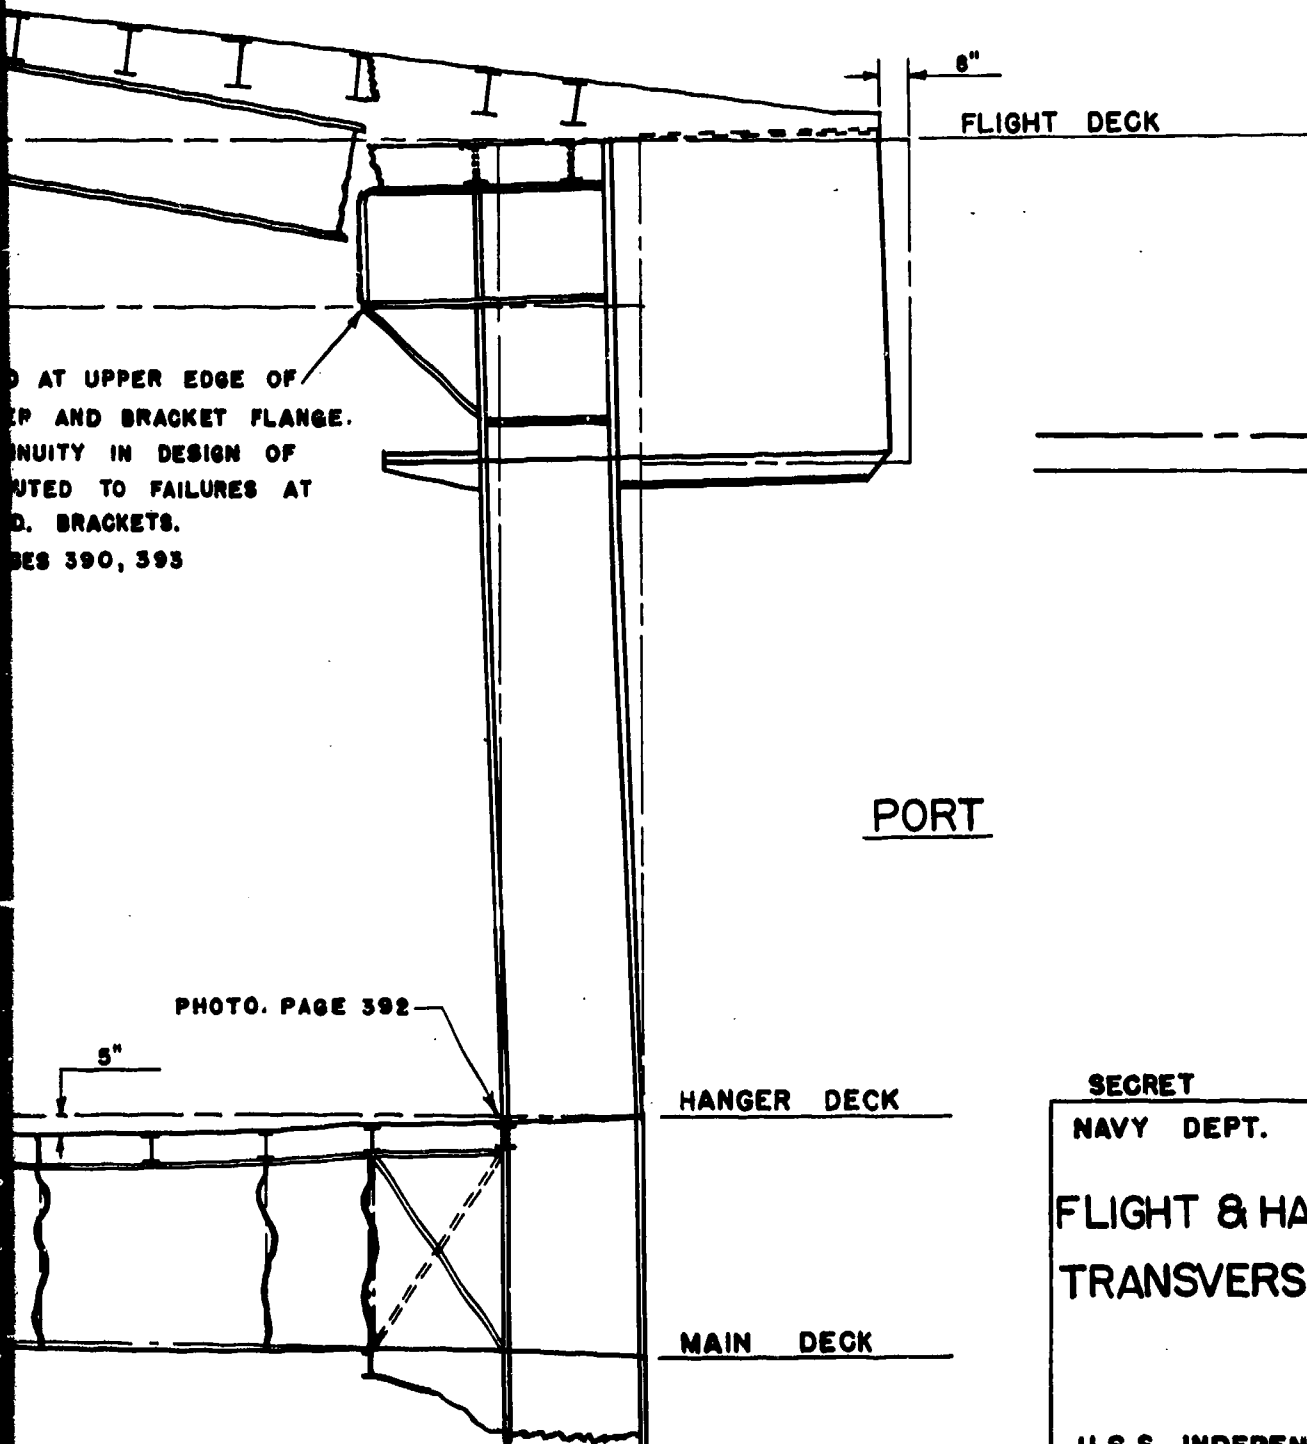
TRANSVERSE SECTION
LOOKING AT

FRACTURES ORIGINATED AT (A) UPPER EDGE
OF WELDS JOINING TRANSVERSE GIRDER AND
BRACKET FLANGE AND (B) COLUMN AND
BRACKET FLANGE.
PHOTOS. - VOL. 3, PAGE 398

D AT UPPER EDGE OF
 IP AND BRACKET FLANGE.
 INUITY IN DESIGN OF
 UTED TO FAILURES AT
 D. BRACKETS.
 RES 390, 393

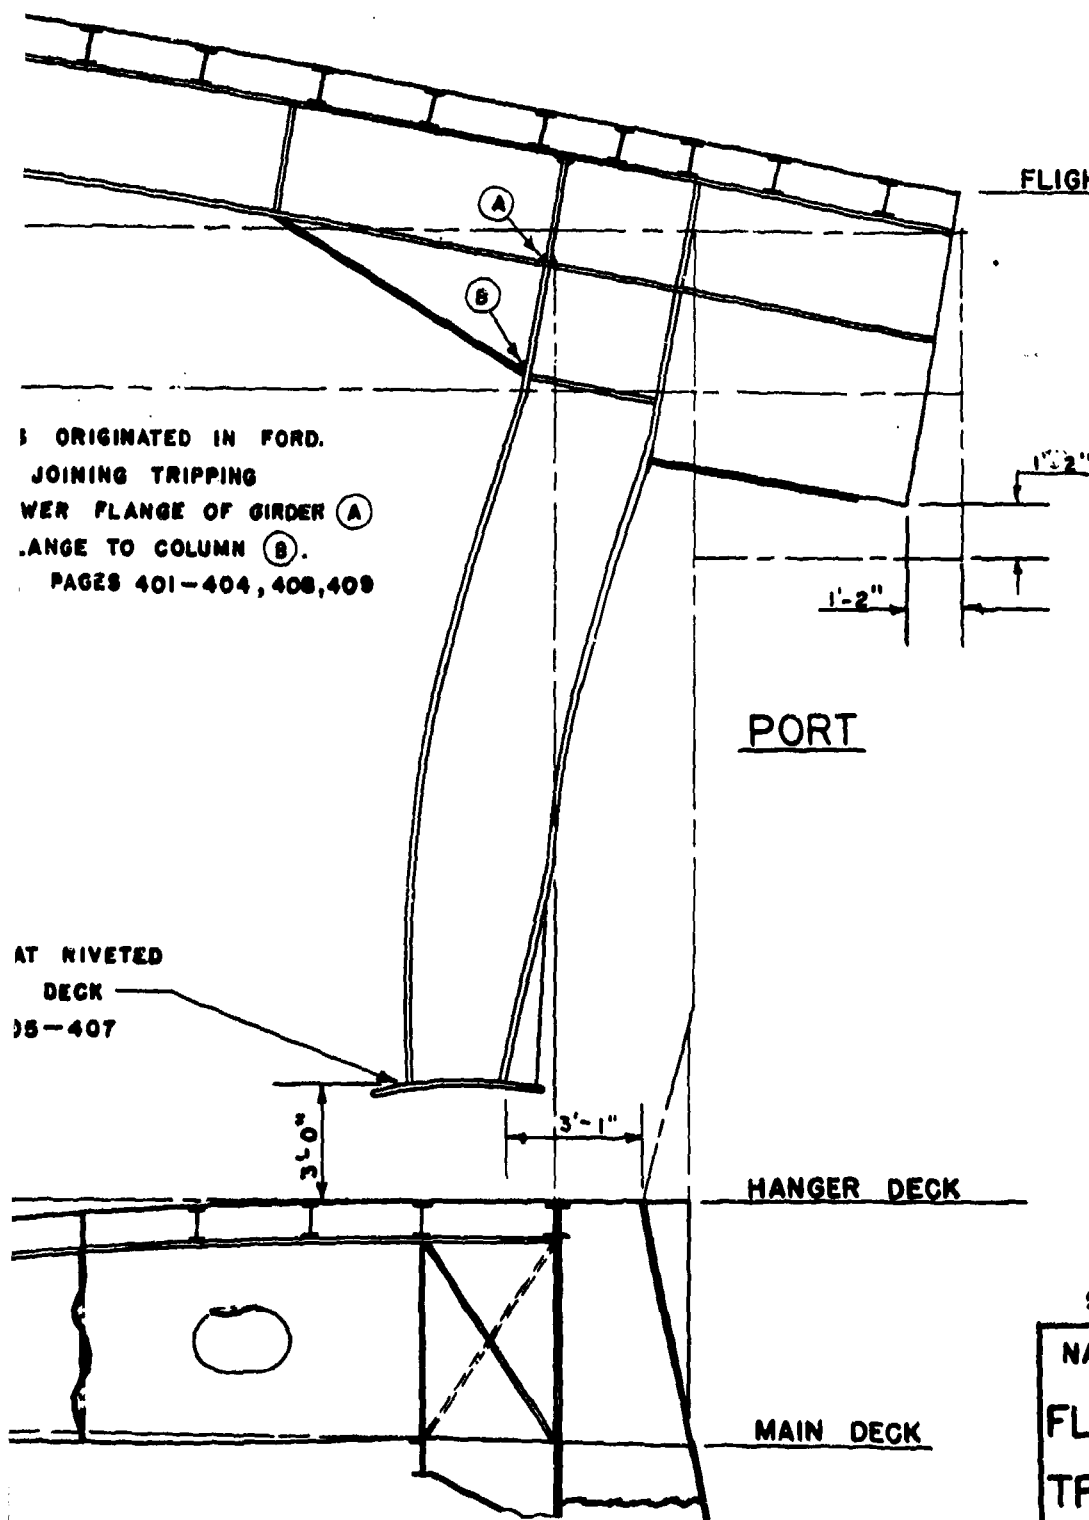
TRANSVERSE SECTION AT FR. 83
LOOKING AFT.

FRACTURE OCCURRED IN WELDS JOINING
BRACKET TO GIRDER AND COLUMN.
THE ORIGIN OF FRACTURE APPEARS
TO HAVE BEEN IN THE WELD JOINING
THE BRACKET FLANGE TO THE COLUMN.
WELDS WERE TOO SMALL TO DEVELOP
100% JOINT EFFICIENCY.
PHOTOS.- VOL. 3, PAGES 400, 416-418, 420

FRACTURE ORIGINATED AT AFTER END OF BUTT WELD IN LOWER FLANGE OF GIRDER. INCOMPLETE WELD PENETRATION CONTRIBUTED TO FAILURE.
PHOTOS.- VOL. 3, PAGES 399, 410-414

SMALL FRACTURES ORIGINATED IN FORD. END OF WELDS JOINING TRIPPING BRACKET TO LOWER FLANGE OF GIRDER (A) AND BRACKET FLANGE TO COLUMN (B).
PHOTOS.- VOL. 3, PAGES 401-404, 408, 409

PULLED LOOSE AT RIVETED CONNECTION TO DECK
PHOTO. PAGE 405-407

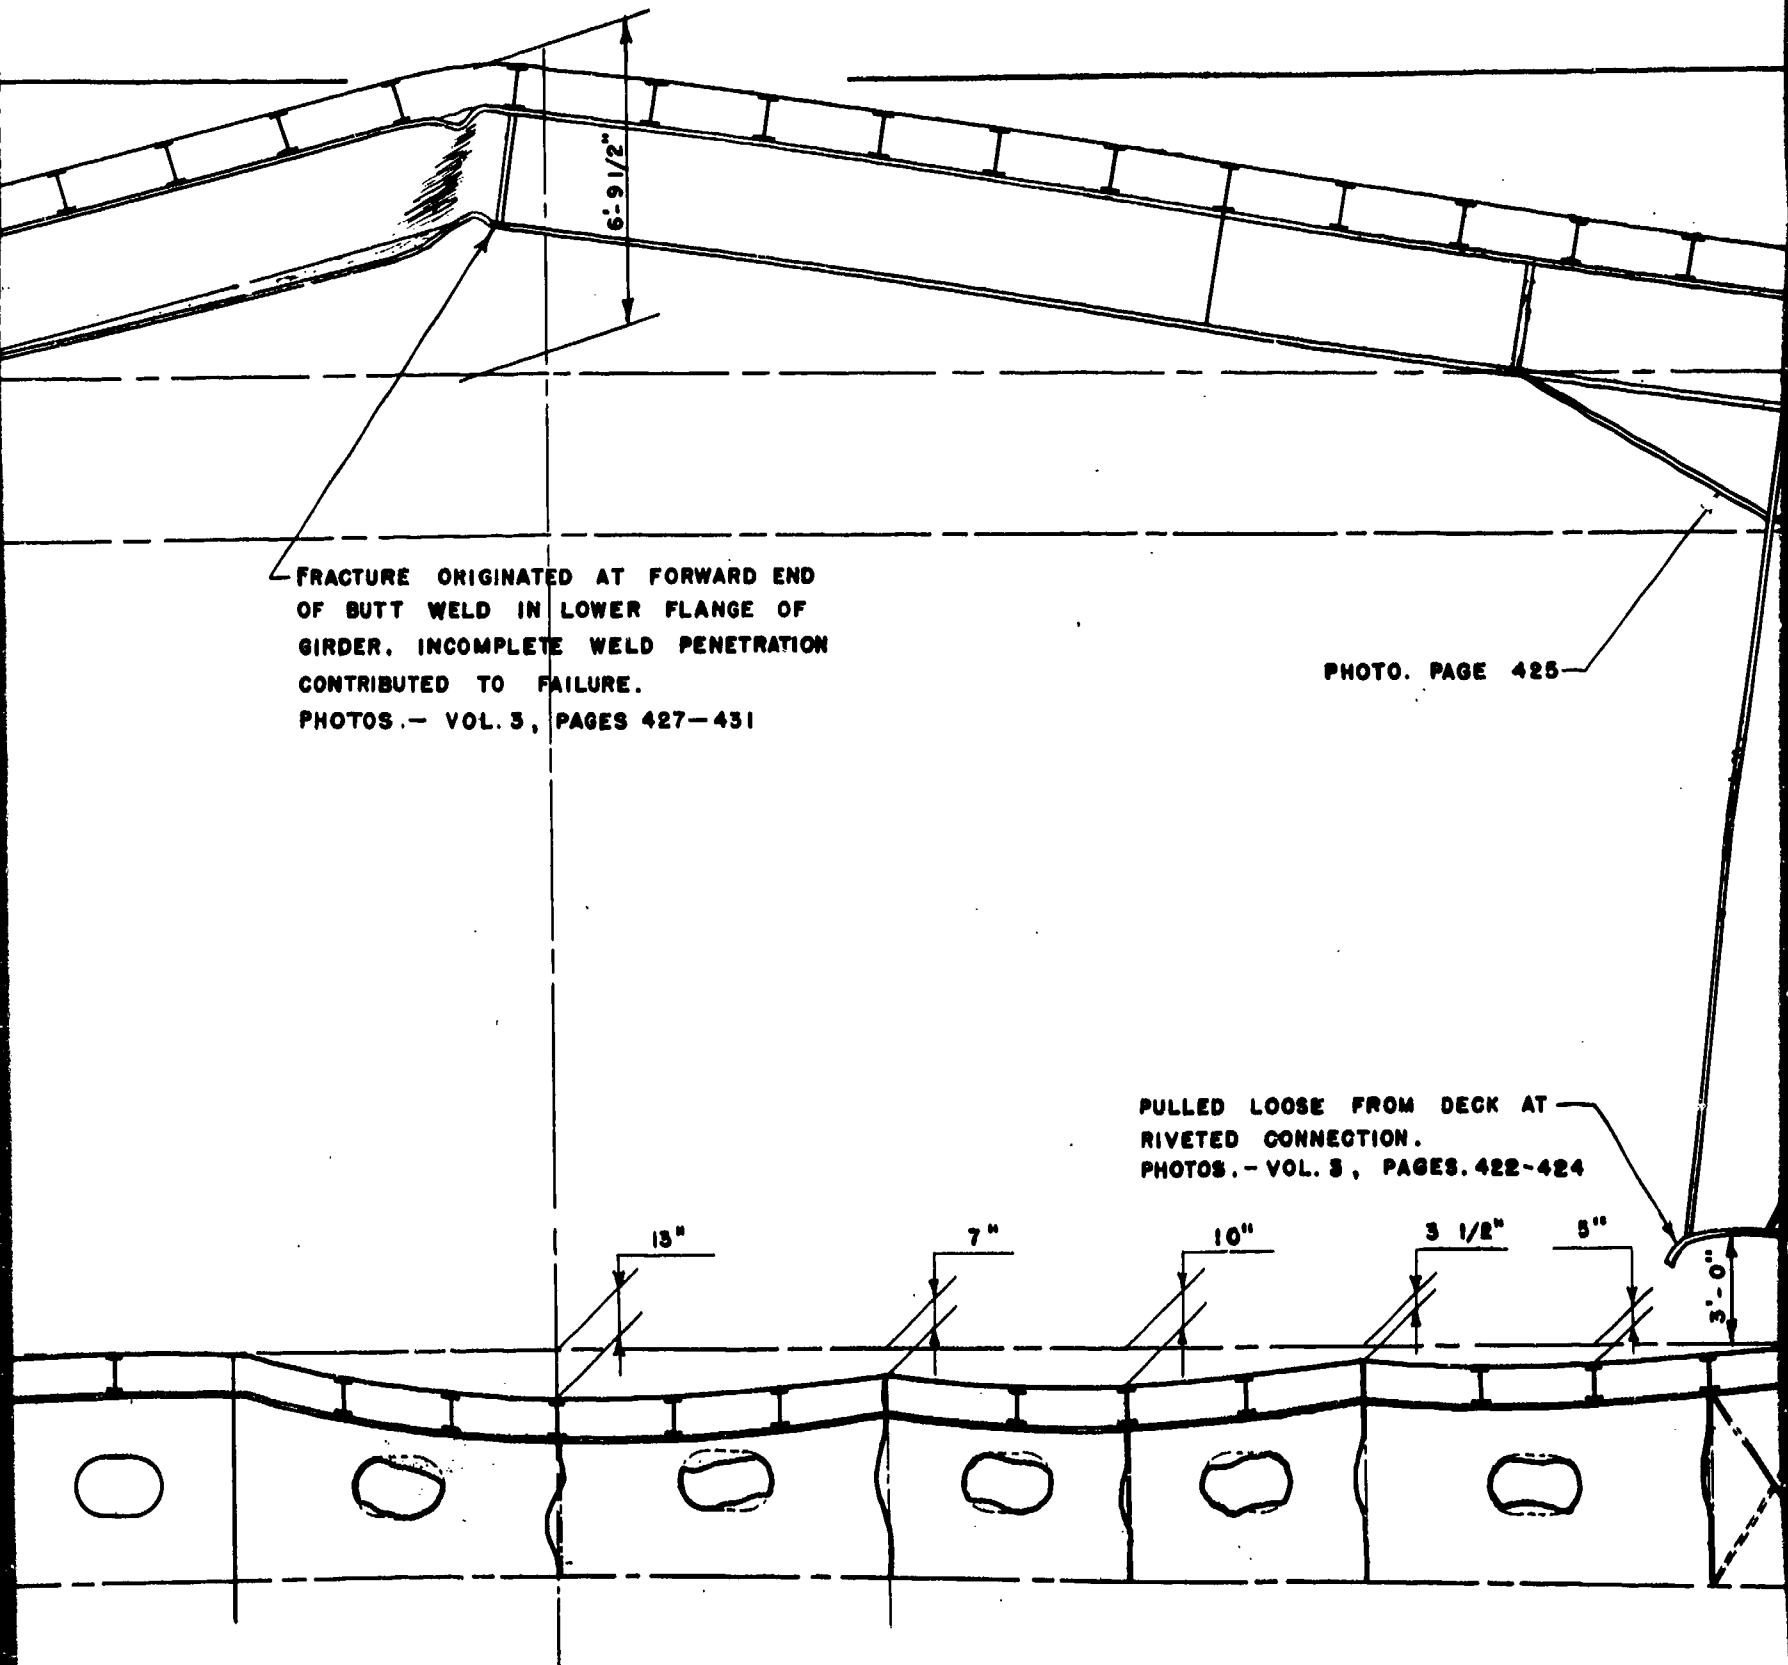
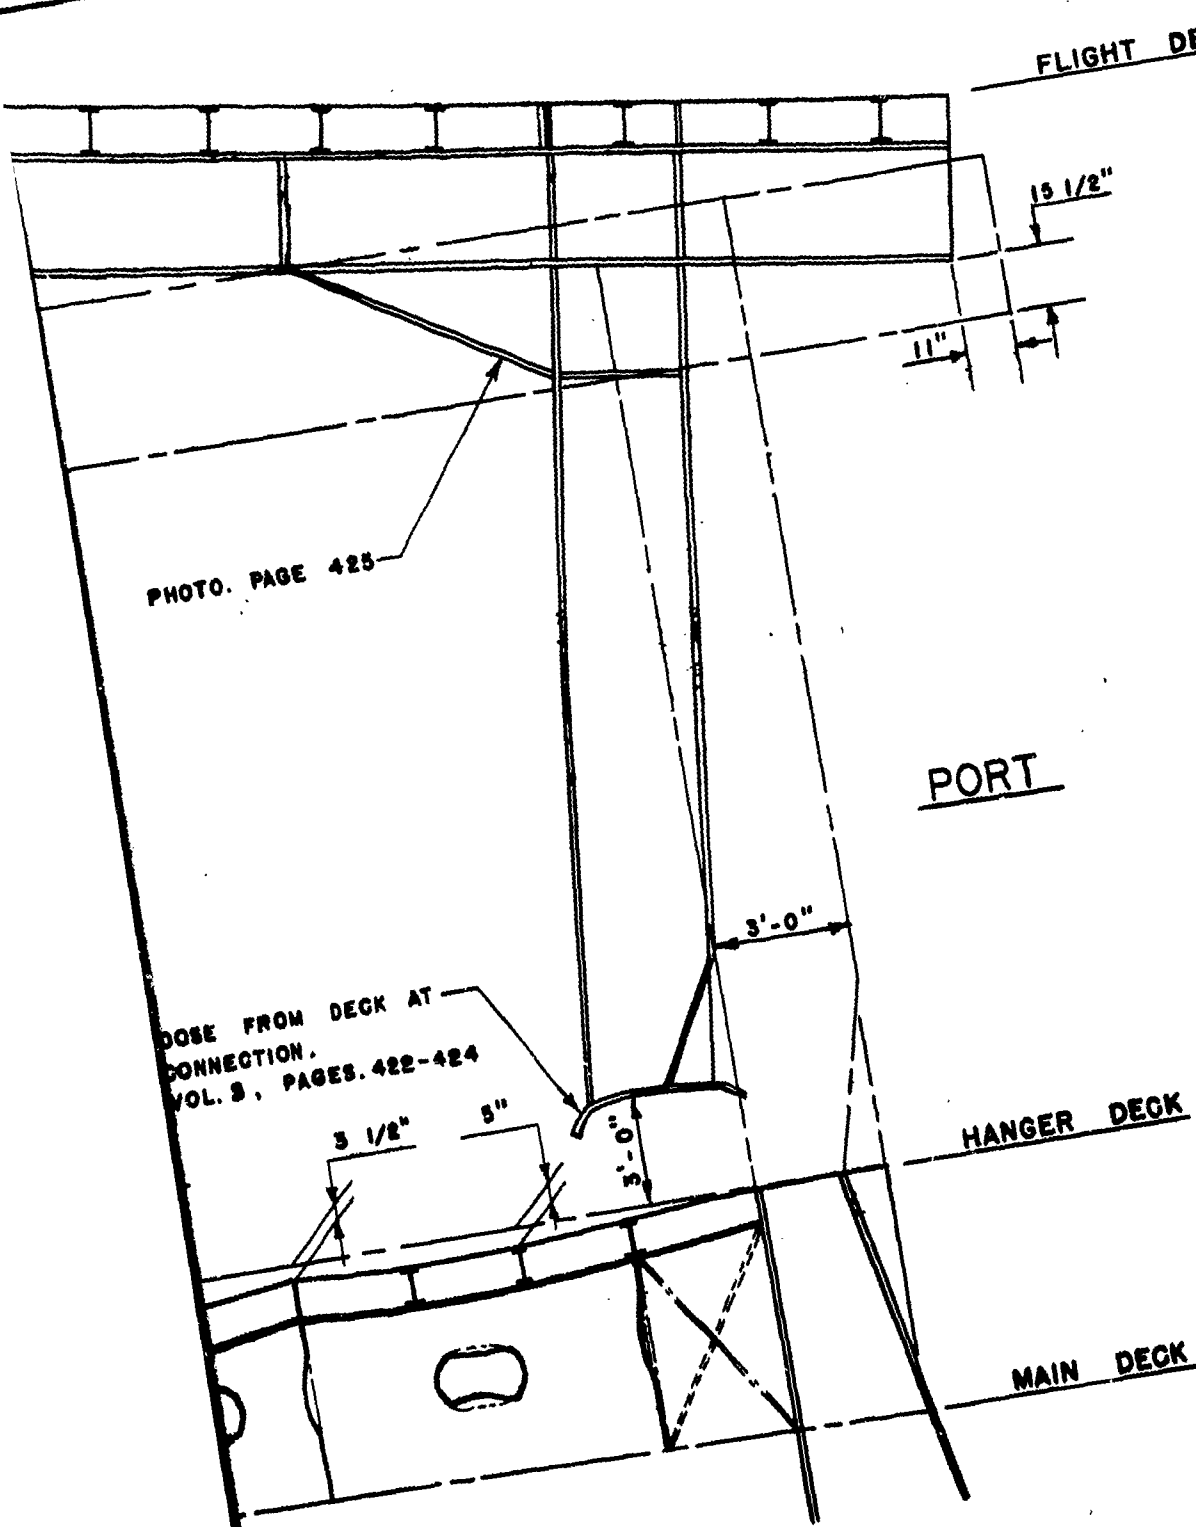
TRANSVERSE
LOOK

FRACTURE ORIGINATED AT EDGE OF
WELD JOINING BRACKET FLANGE TO
COLUMN. STRUCTURAL DISCONTINUITY
IN DESIGN OF CONNECTION CONTRIBUTED
TO FAILURE.
PHOTOS.— VOL. 3, PAGES 432-435

PULLED LOOSE FROM DECK AT
RIVETED CONNECTION.
PHOTOS.— VOL. 3, PAGES 436-438

PHOTO. PAGE 425

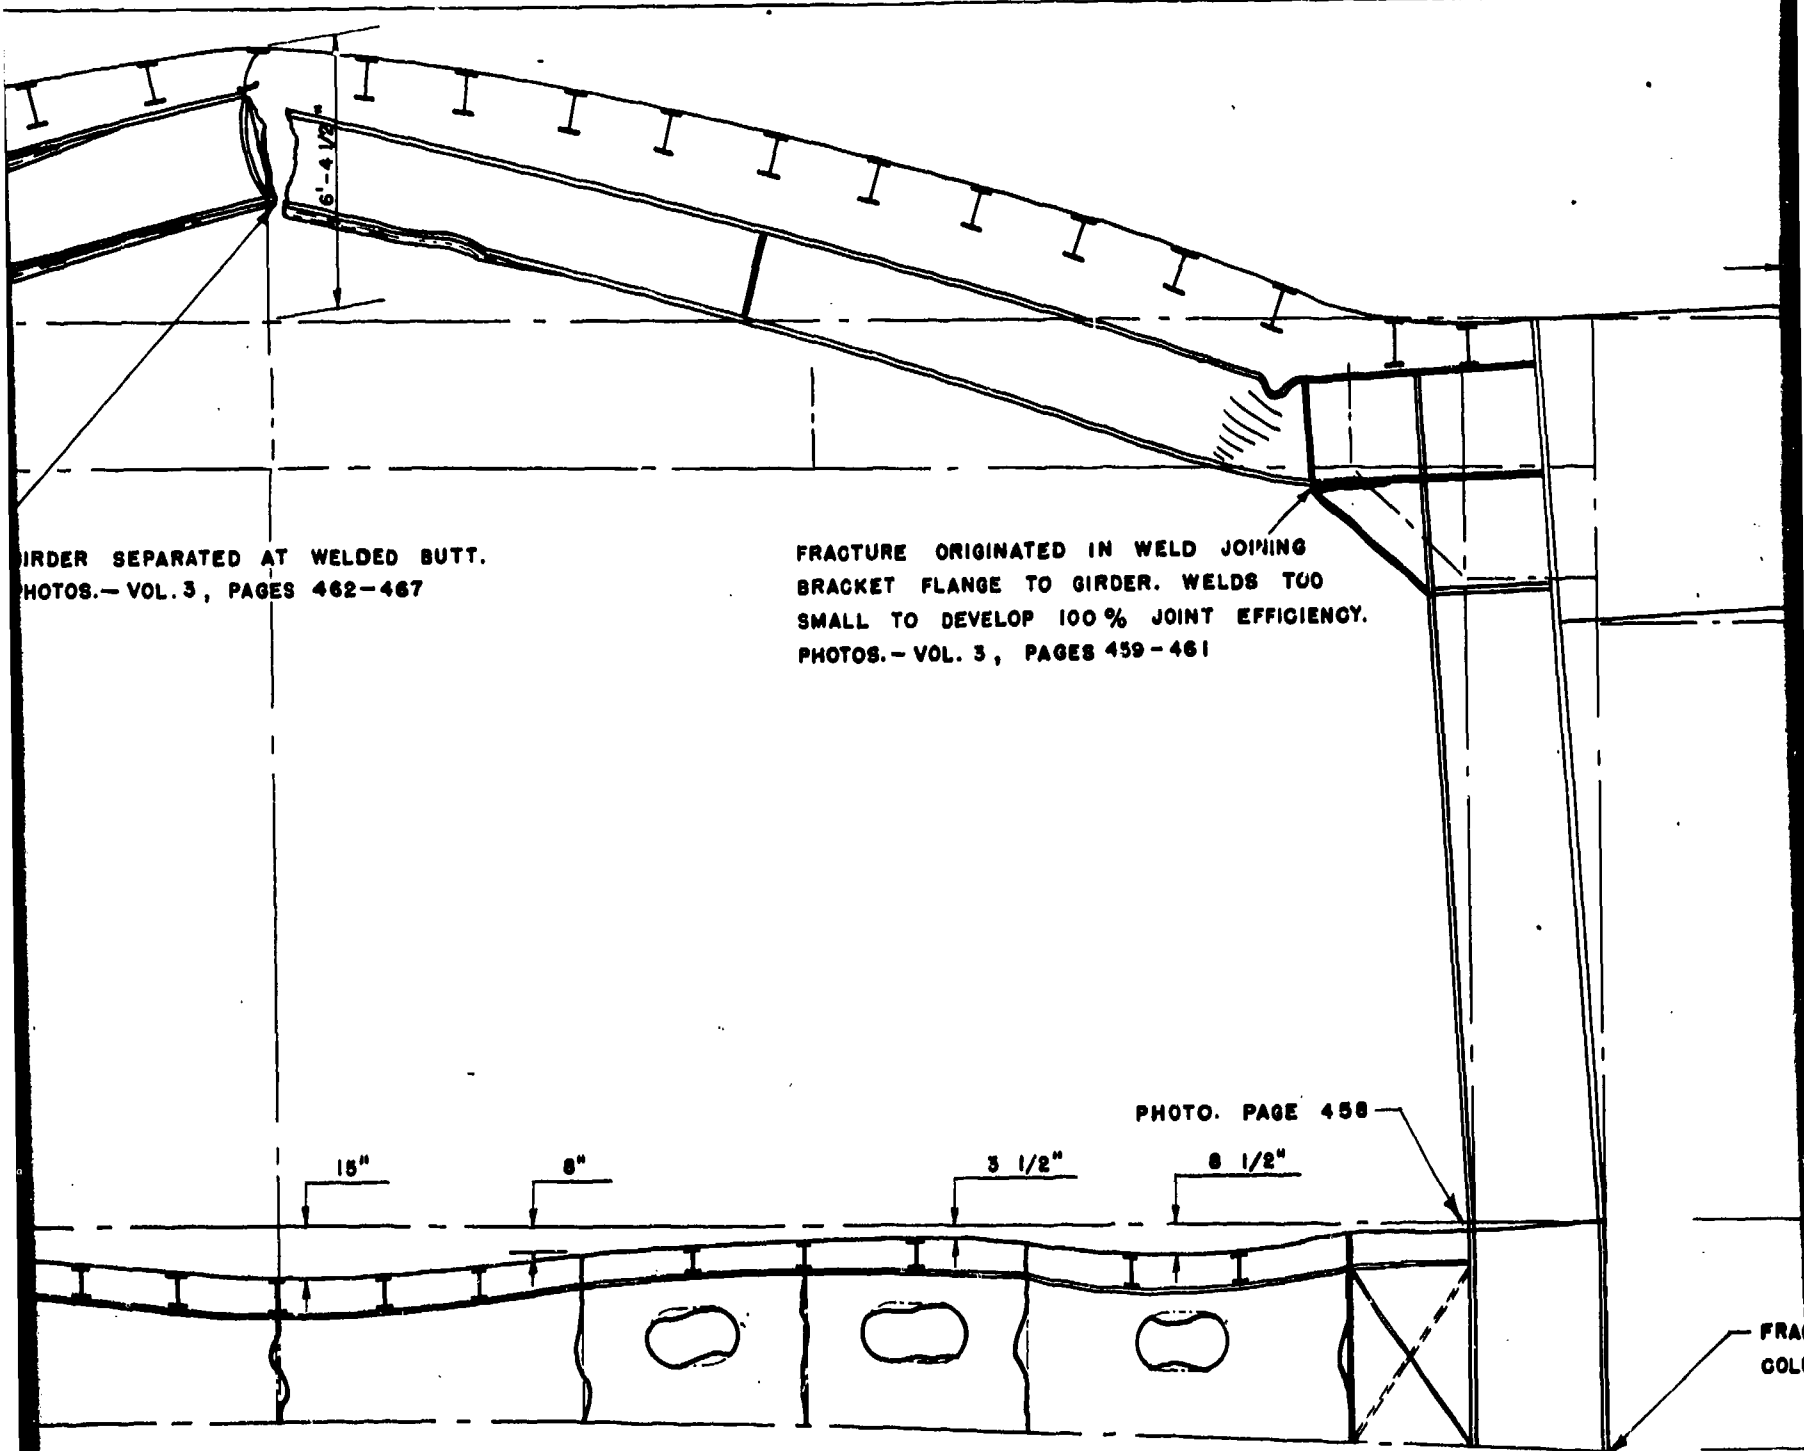
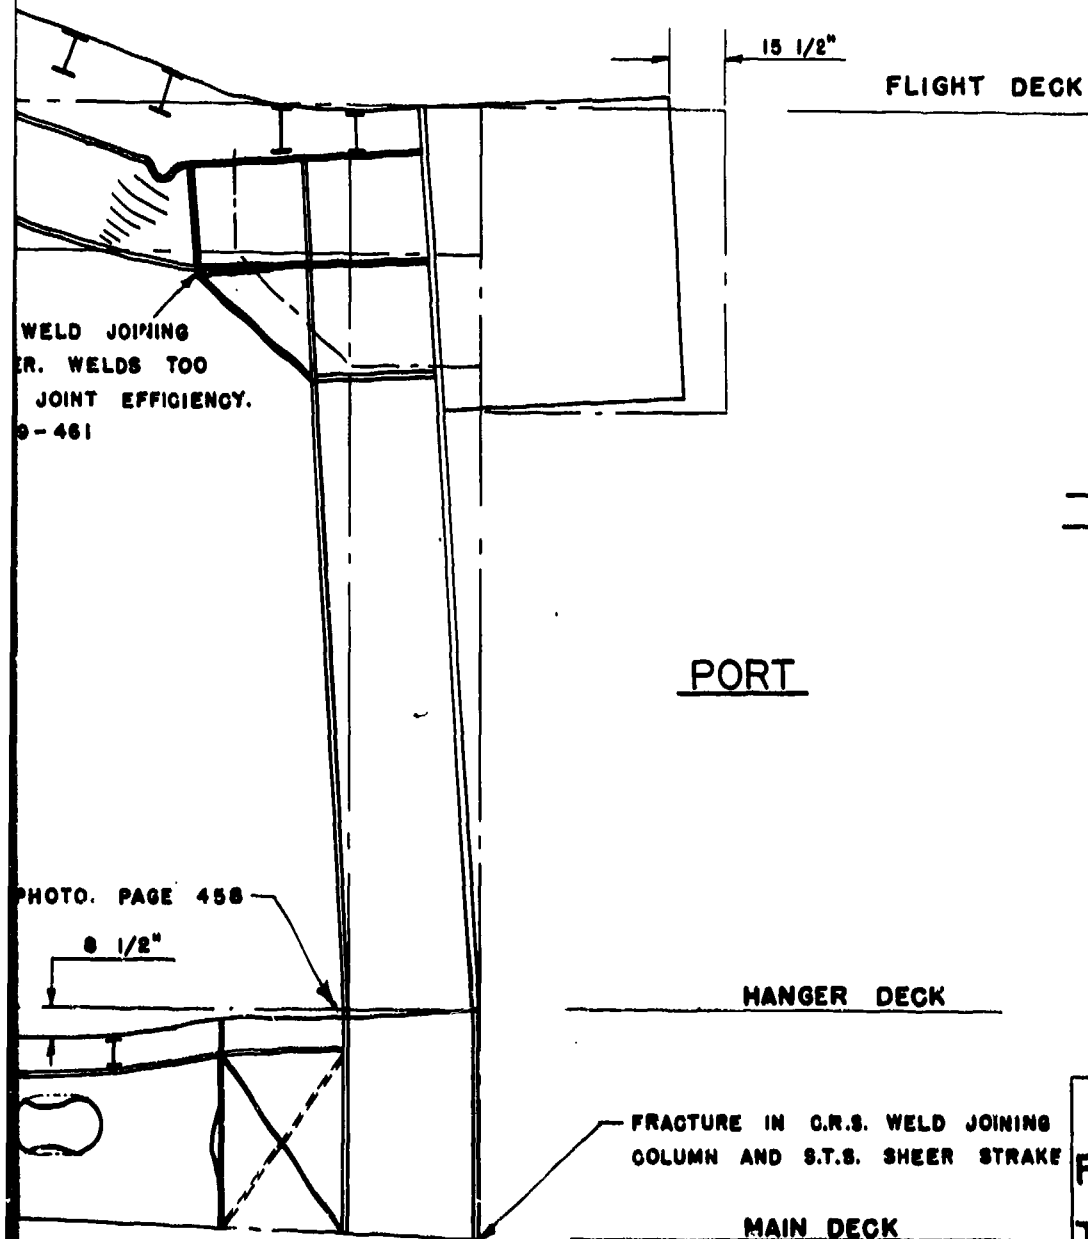
VERSE SECTION AT FR.92
LOOKING AFT.

GIRDER SEPARATED AT WELDED
PHOTOS.— VOL. 3, PAGES 462-4

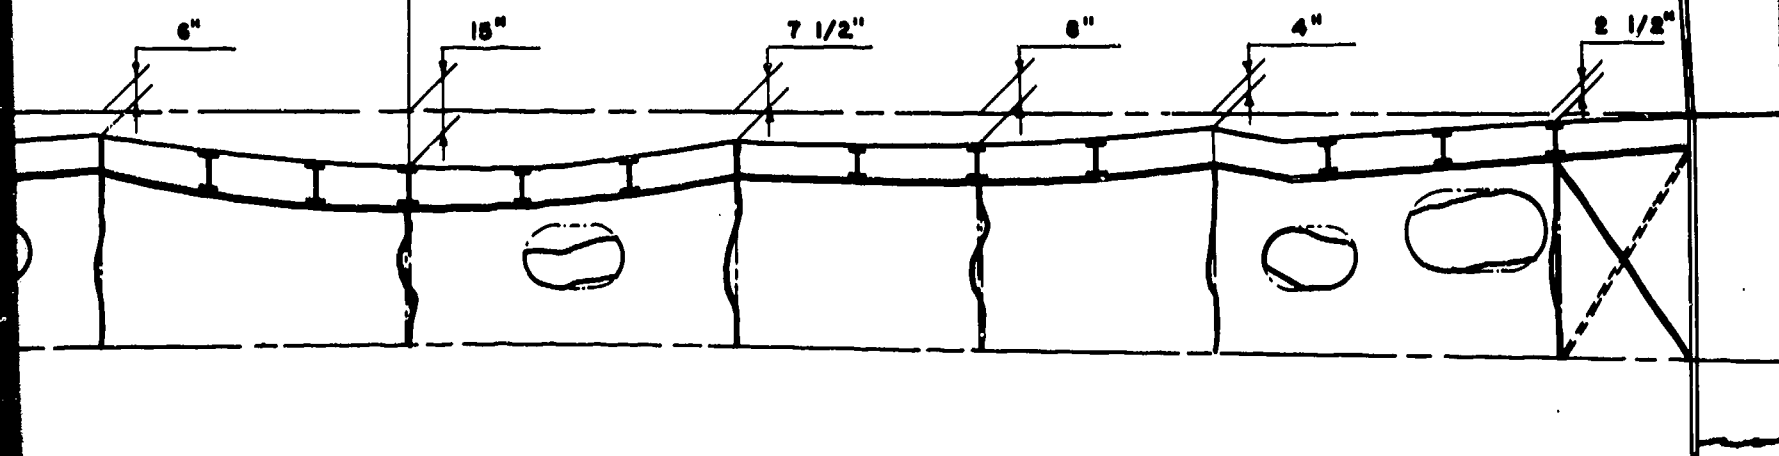
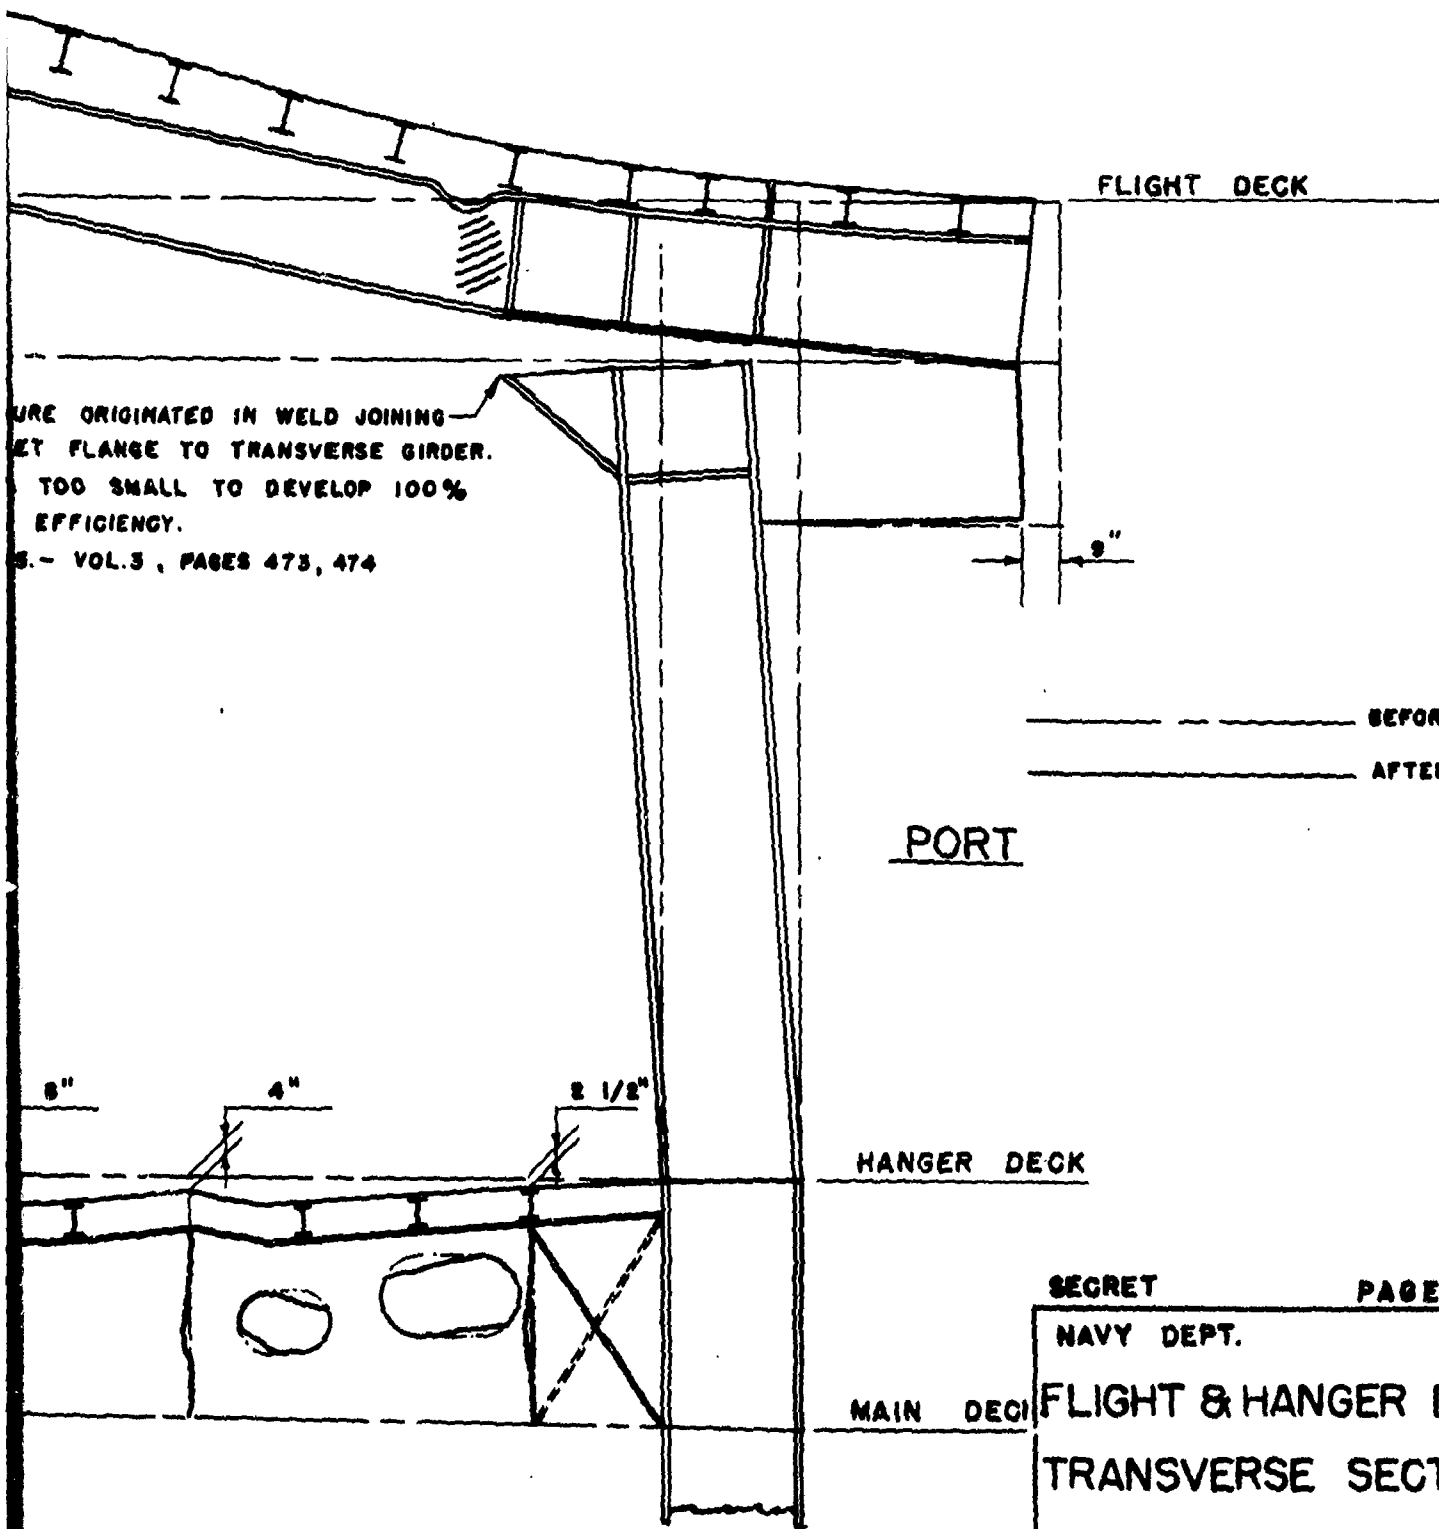
TRANSVERSE SECTION AT FR. 95
LOOKING AFT

FRACTURE ORIGINATED IN BUTT WELD IN
LOWER FLANGE OF GIRDER.
PHOTOS.— VOL. 3, PAGES 475-483

FRACTURE ORIGINATED IN WELD JOINING
BRACKET FLANGE TO TRANSVERSE GIRDER.
WELDS TOO SMALL TO DEVELOP 100%
JOINT EFFICIENCY.
PHOTOS.— VOL. 3, PAGES 473, 474
